BoxBarrier® Testing

RESULTS

Dremp, September 8th 2011

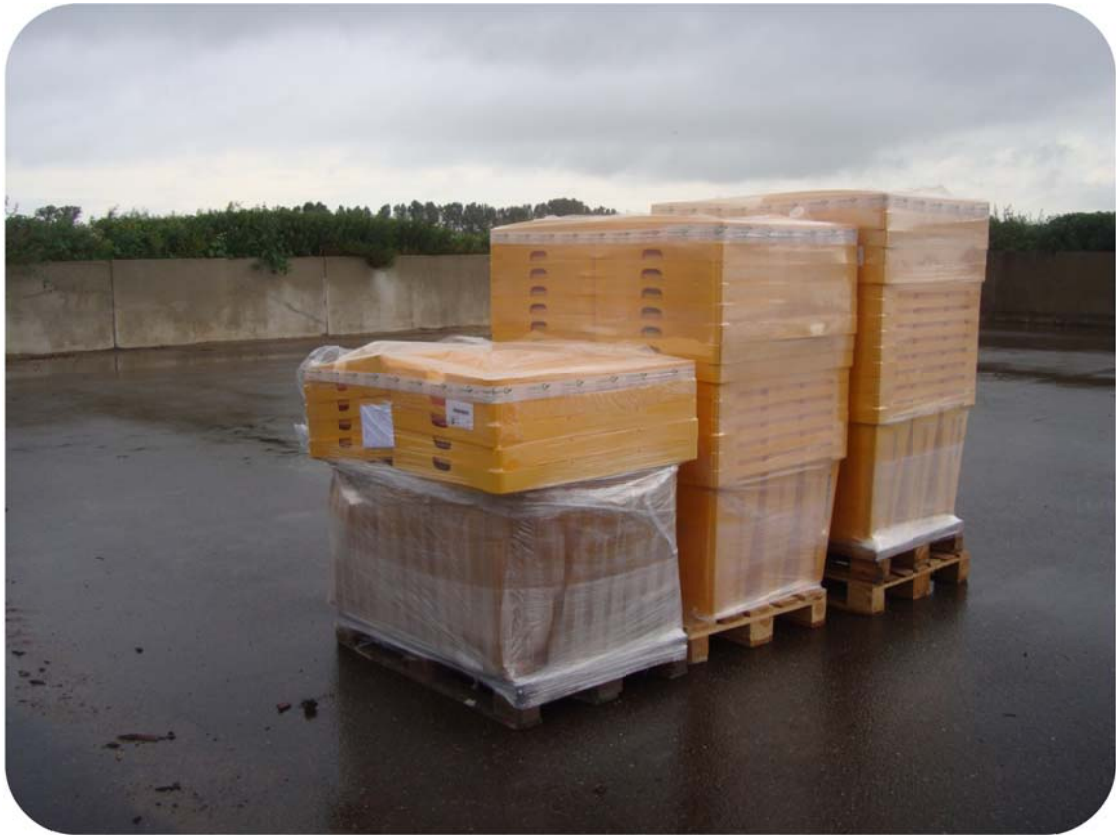
Durability

A falling stack of lids is no problem – there is no damage at all.
Also throwing of Boxbarriers and other parts does no damage.
The material is very durable.

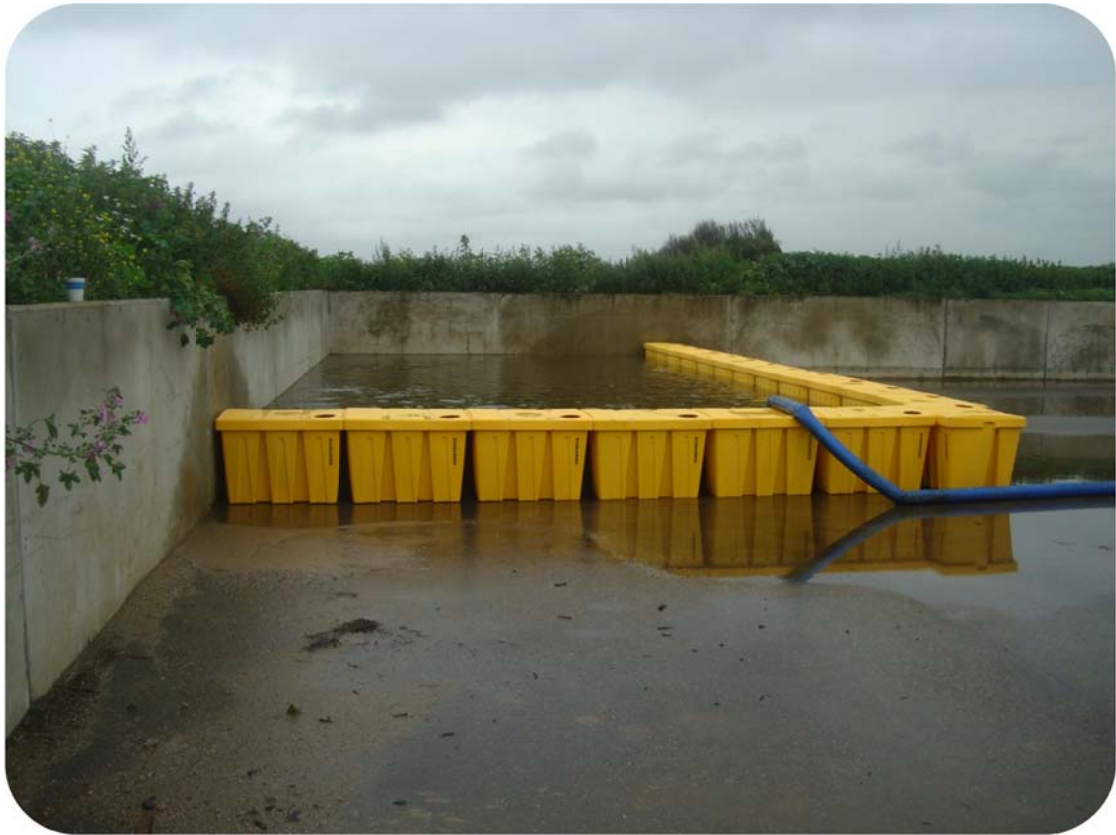
Stability on asphalt

A single wall of Boxbarriers withstands 50 cm of water in the basin without movement.

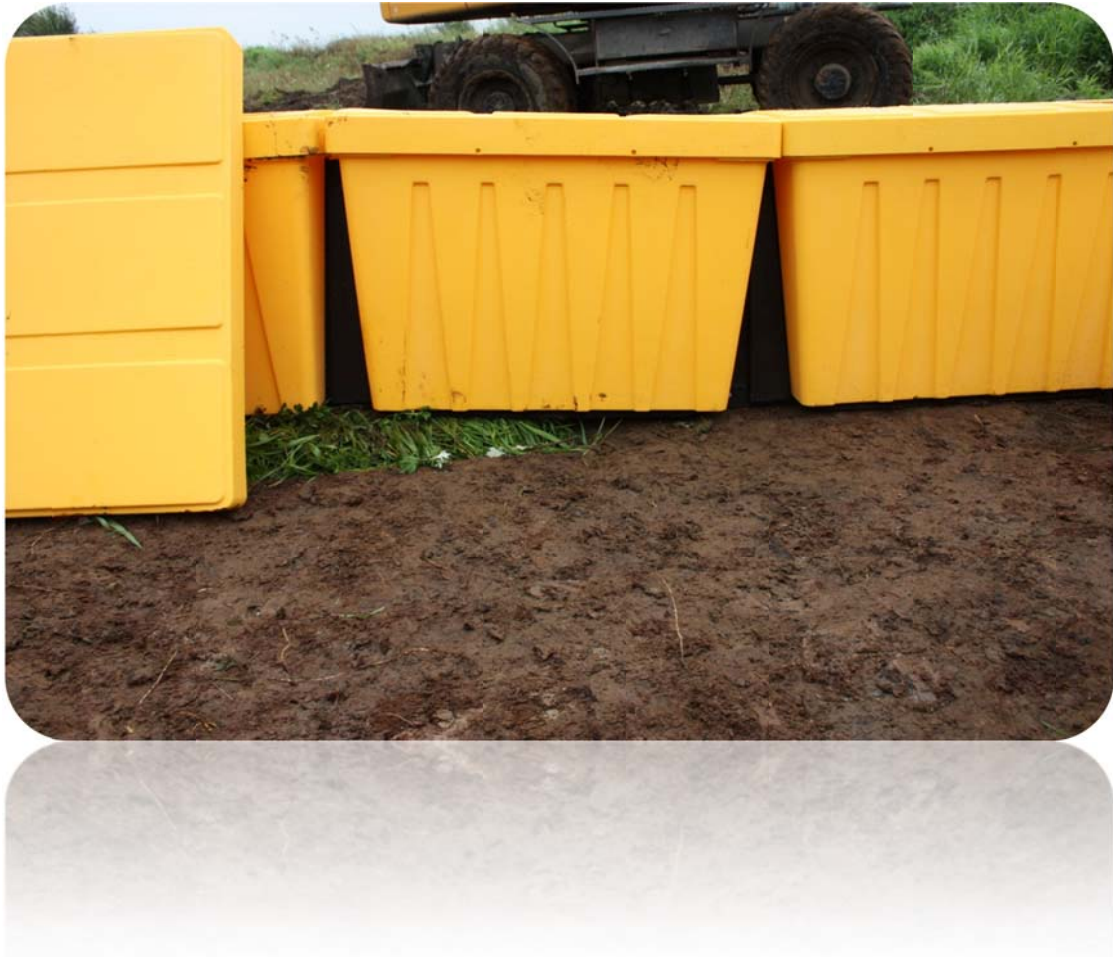
The Boxbarrier on Soil and Grass

This picture shows the switch from grassland to soil. As seen on the following pictures the switch is no problem and neither is the grass itself. Both are watertight. Uneven soil can lead to piping, grass prevents this.

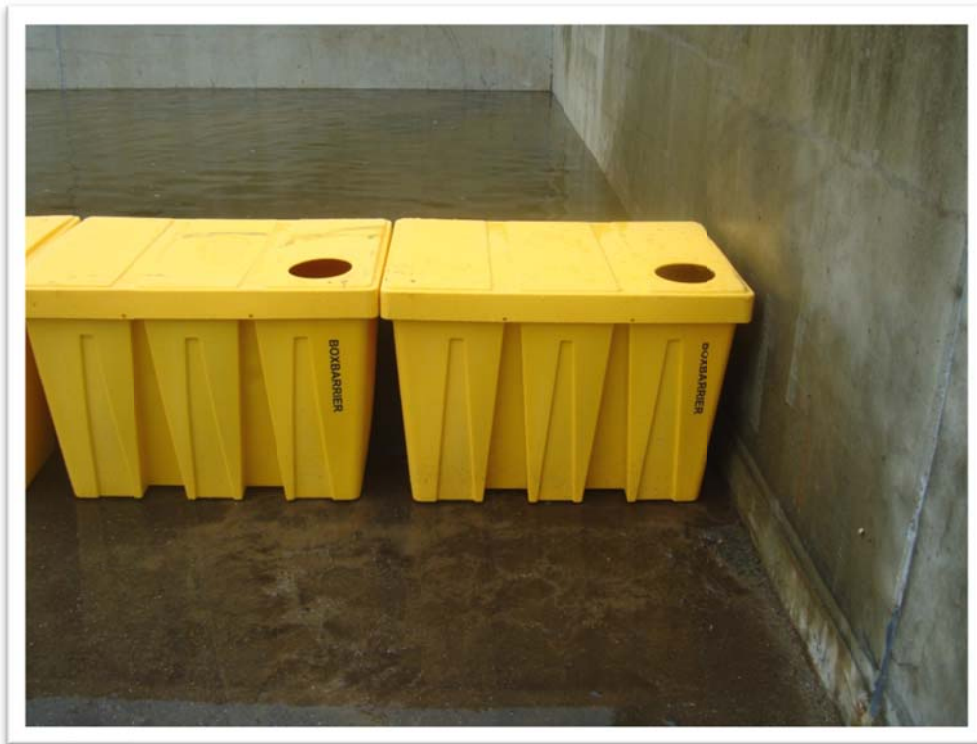
Around and about (1)

For sealant to the wall, half a keg was used and sealed with a rubber strip. This worked very well, there was no leak evident.

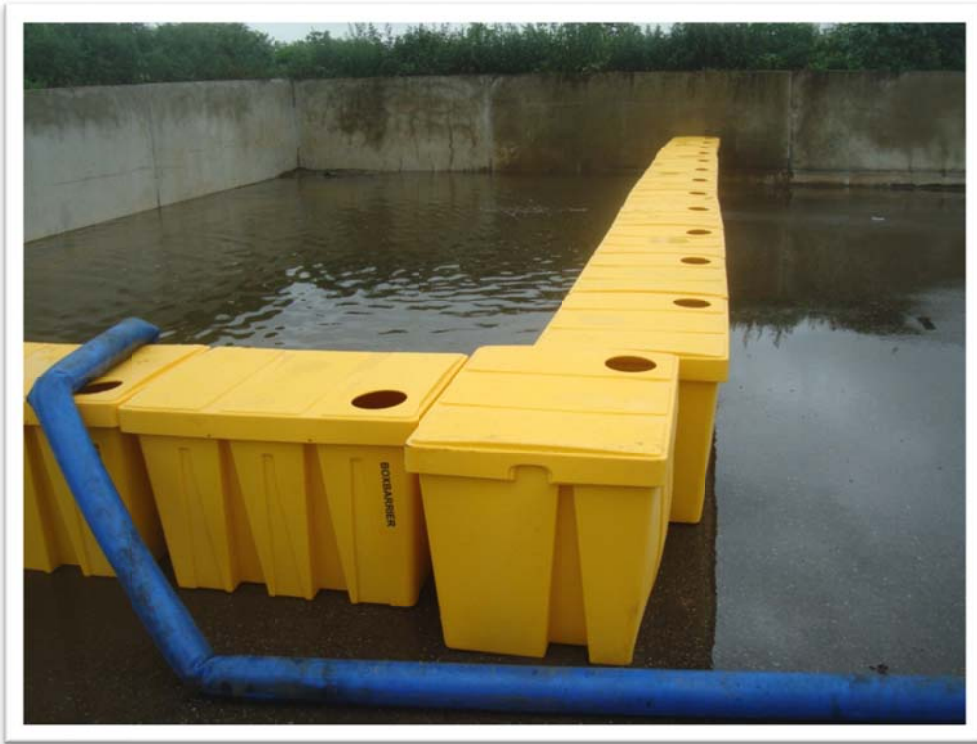
Around and about (2)

For the edge a Boxbarrier itself was used and connected as usual with a keg on the side and here in particular at the back side, also with a keg.

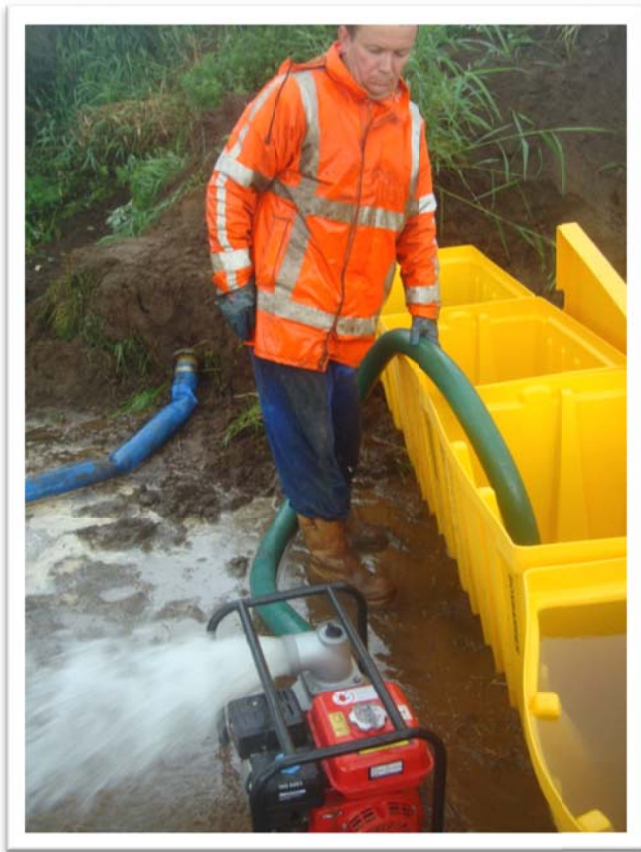
A fuel-driven portable water pump was used to empty out the Box barriers.

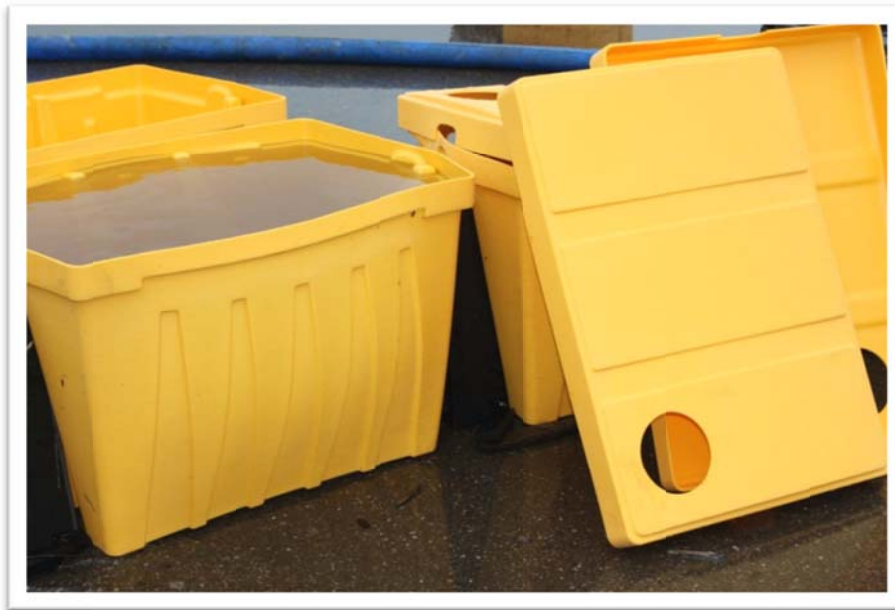
Around and about (3)

This picture shows filled, dent out Boxbarriers in contrast to emptied out Boxbarriers and lids, that got back into shape again.

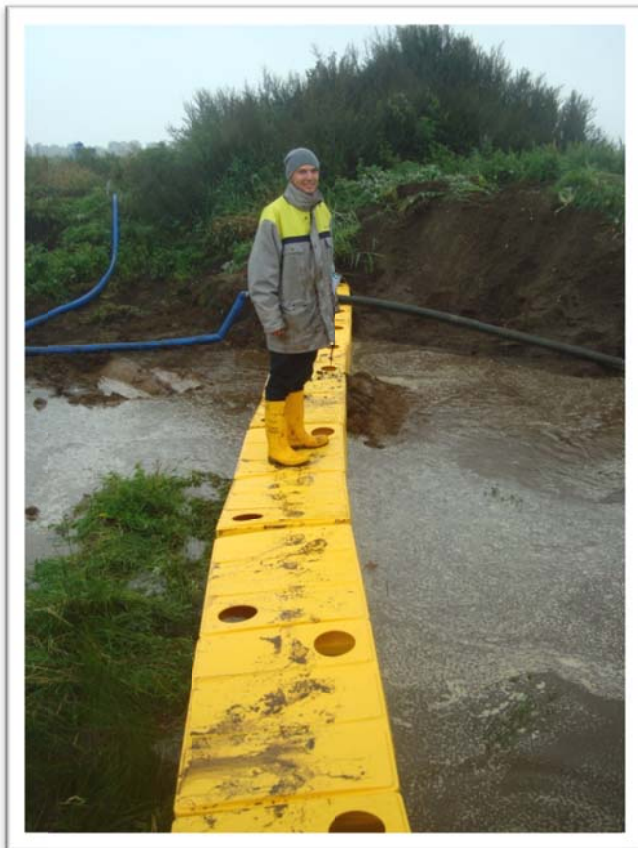
The Boxbarrier is stable enough to walk on it.
